CEDAR LAKE ENHANCEMENT
ASSOCIATION, INC.
Cedar Lake, Indiana

**CEDAR LAKE
DIAGNOSTIC FEASIBILITY STUDY**

April 2001

**Harza Engineering Company, Inc.
Chicago, Illinois**

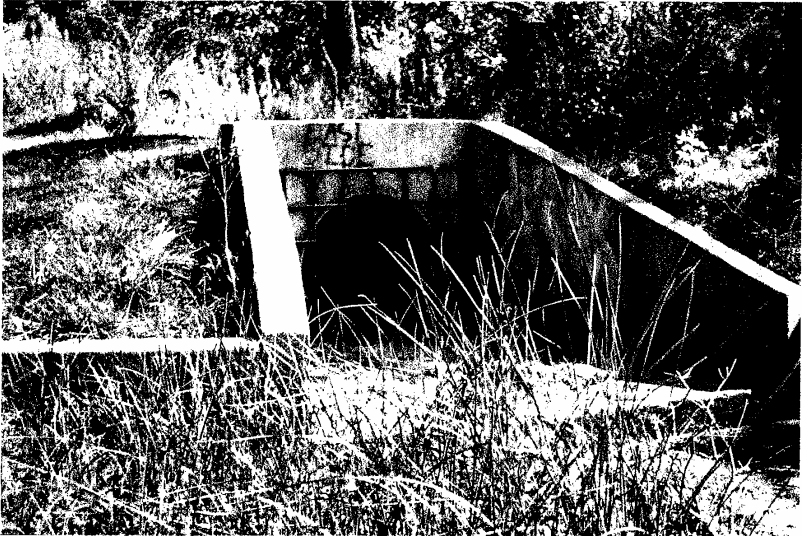
Picture 1: Inlet by the Old Bank Building.

Runoff enters Cedar Lake from two 2-foot diameter concrete storm sewers near the Old Bank Building. The subwatershed is approximately 164 acres of wooded and residential areas along with sporadic commercial development (Table 3-2). The culverts are under the intersection of Morse Street and 133rd Avenue. These areas are shown in Appendix A, photos 1 and 2.

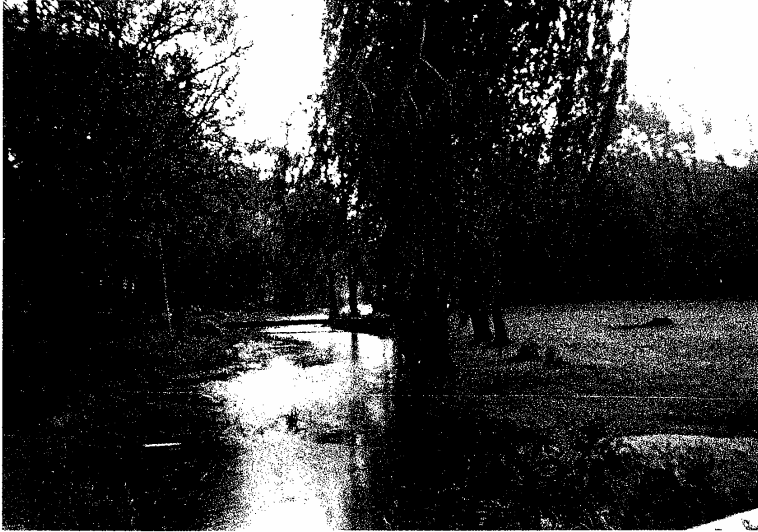
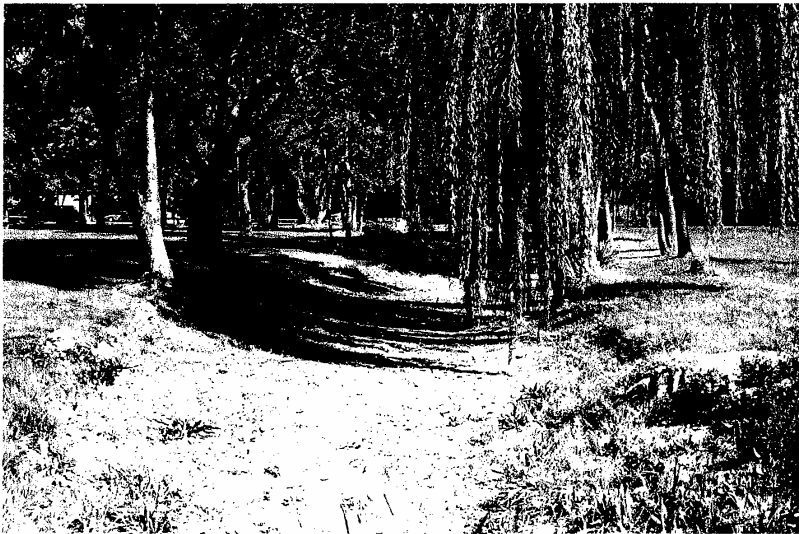
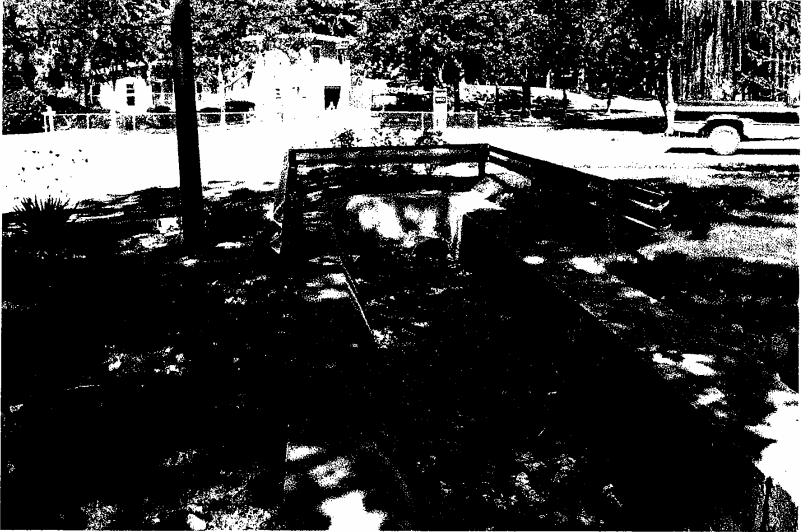
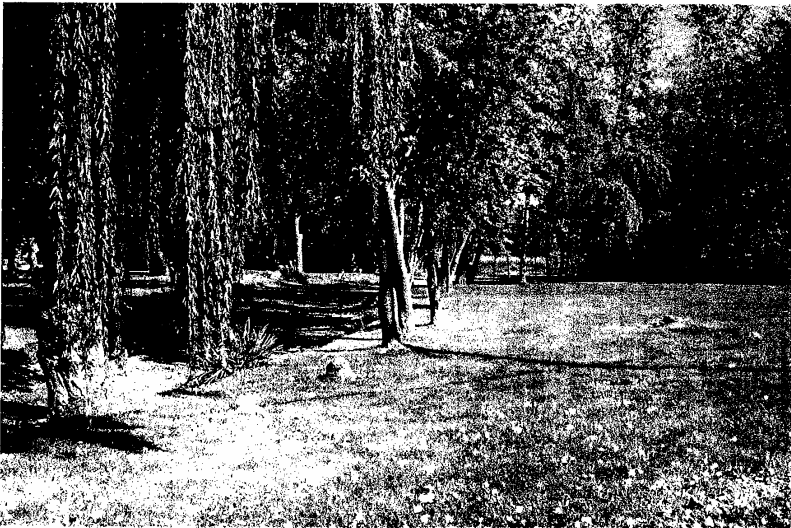
Picture 3: Chamber of Commerce Wetland during storm event.

Picture 4: Chamber of Commerce Wetland during dry weather.

Picture 5: Chamber of Commerce inlet.

Picture 6: Chamber of Commerce Wetland watershed.

This subwatershed drains through a small 11-acre wetland and discharges under 133rd Avenue into Cedar Lake via a 1-foot diameter stainless steel culvert. The culvert is in poor condition, effectively slowing flow through it. Vegetation is not well established in the wetland, likely because water levels fluctuate greatly with the majority of water occurring during large runoff events. The subwatershed is approximately 164 acres and it drains predominantly undeveloped wooded or residential areas (Table 3-1). Runoff originates from a hilly area (up to 60 feet higher than the wetland) east of the wetland and enters Cedar Lake through a small, defined channel. These areas are shown in Appendix A, photos 3, 4, 5, and 6.

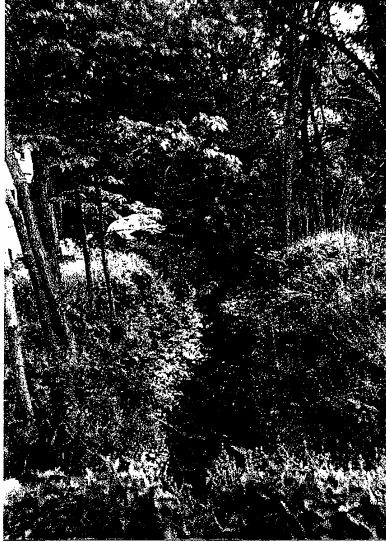
Picture 7: North inlet into North Point Marina.

This subwatershed is located on the northwest side of Cedar Lake. Two smaller streams discharge into a larger channel that flows to Cedar Lake. Both streams flow through largely wooded areas encompassing a subwatershed of approximately 332 acres (Table 3-4). Numerous trailers, serving as summer homes, are located near this channel. This area is shown in Appendix A, photo 7.

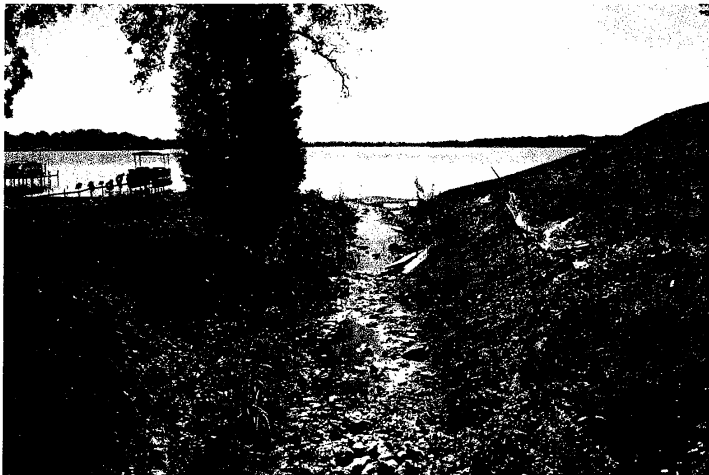
Picture 8: Condos Inlet.

acre subwatershed is predominantly wooded (Table 3-5). This area is shown in Appendix A, photo 8.

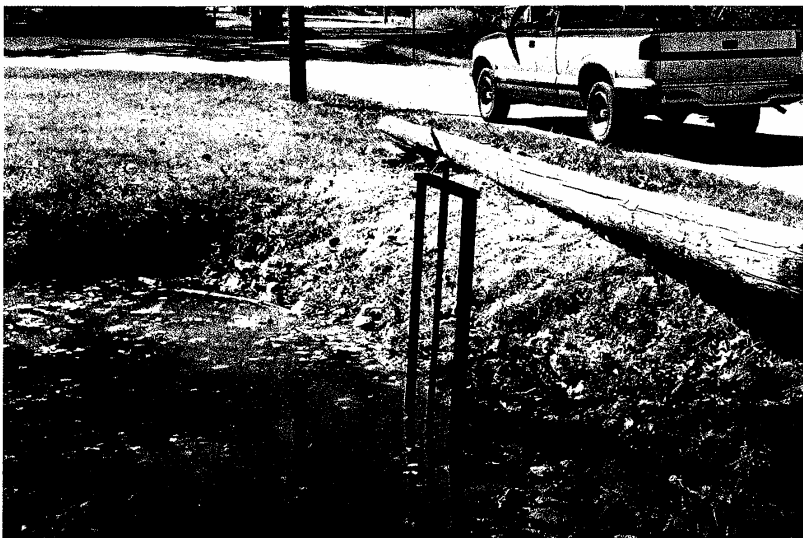
Picture 9: Weir at Golf Course Inlet.

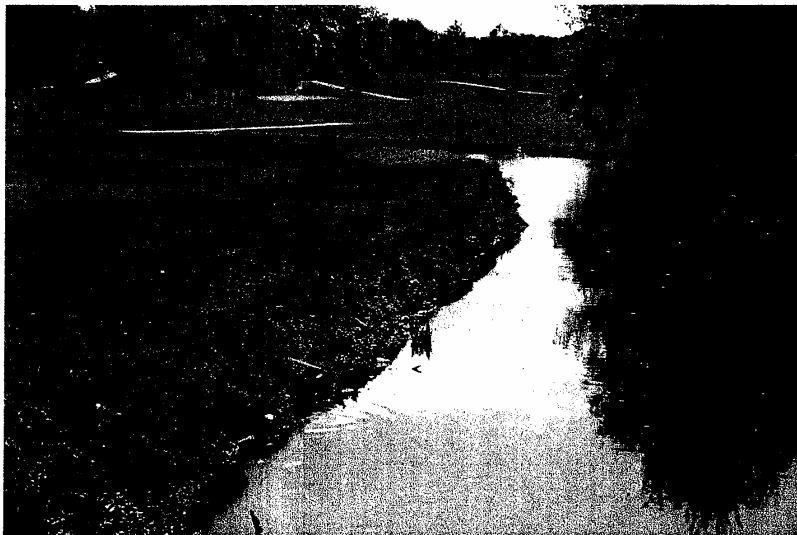
Picture 10: Failing stream banks at Golf Course Inlet.

The streambanks along the Golf Course Inlet are severely eroding. The sediments in the bottom of the channel are likely saturated with nutrients as drainage from the golf course is likely to contain fertilizer residuals. It is recommended that the CLEA assist the South Shore Country Club in stabilizing their streambanks. The length of the channel in this watershed is approximately 2,500 feet. Assuming an average installed cost of \$50 per foot for biological treatment such as plugged coir fiber rolls, the estimated cost to stabilize both banks for the entire length of channel would be \$250,000. If funds are not available to stabilize the whole channel, those portions closest to the lake should get priority. With a vegetative system such as coir fiber rolls that can be installed directly into the channels, land loss and disturbance will be minimal.

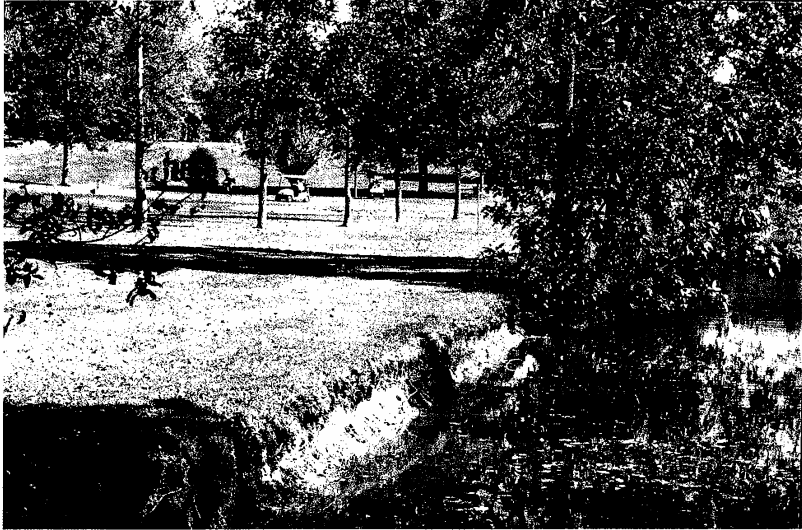
Picture 11: Golf Course Inlet watershed.
